SMITHSONIAN INSTITUTION
BUREAU OF AMERICAN ETHNOLOGY
BULLETIN 92

SHABIK'ESHCHÉE VILLAGE

A LATE BASKET MAKER SITE
IN THE CHACO CANYON
NEW MEXICO

FRANK H. H. ROBERTS, JR.

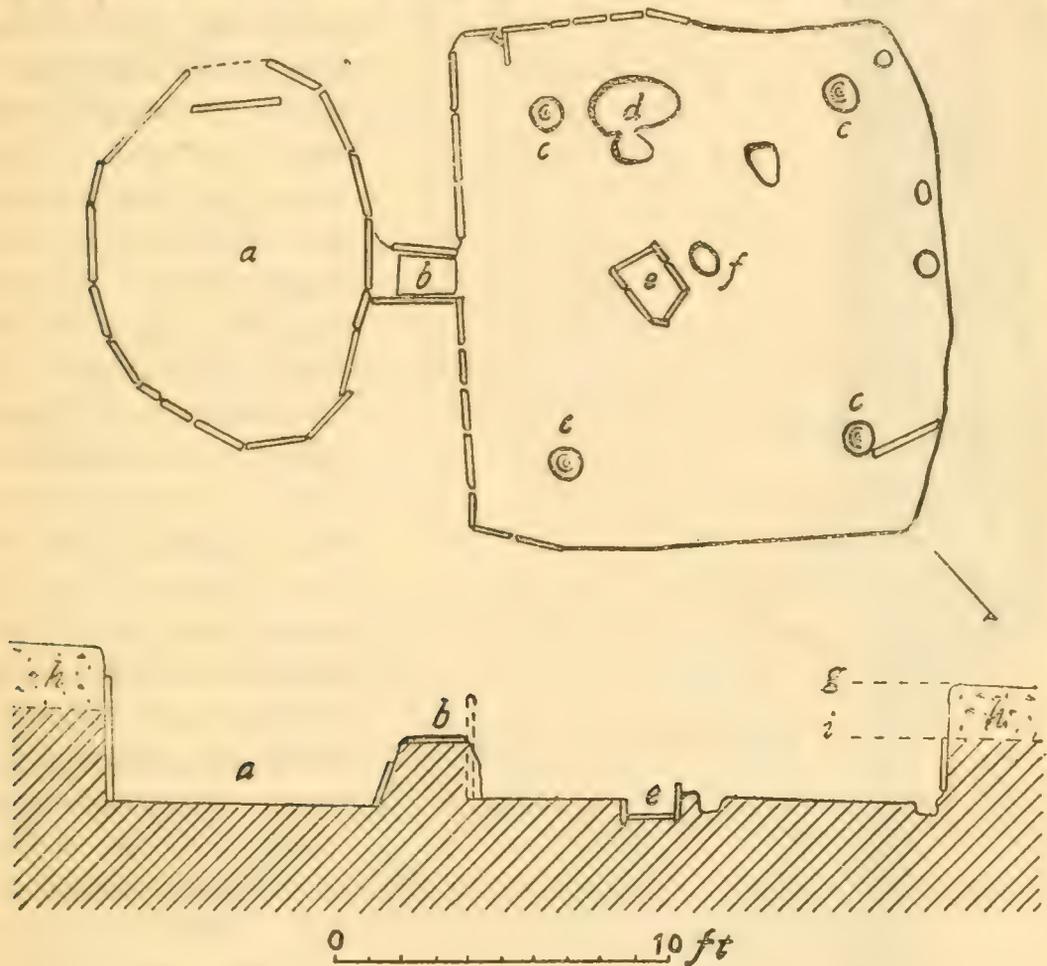
FIG. 1.—Plan of House A. *a*, Antechamber. *b*, Passage. *c*, Holes for support posts. *e*, Fire pit. *f*, Sipapu. *g*, Present ground level. *h*, Débris of accumulation. *i*, Ground level at time of occupation of house

A good example of the rectangular dwelling was found in house A. (Pl. 2, *a*; fig. 1.) All that remained was the excavation, but there was sufficient evidence in the débris-filled interior to indicate what the structure had been like. Large slabs had been used to line one and portions of two other sides of the excavation, the remainder having had the plaster applied directly to the native earth.

In the floor, about 2 feet (60.96 cm.) from each corner, were four holes containing fragments of decayed wood; the remains, no doubt, of posts which had supported the upper walls and roof. Judging from the size of the holes the posts must have averaged about 10 inches (25.4 cm.) in diameter. These roof supports had been placed approximately in the directions of the four cardinal points of the compass.

distance from the wall. (Fig. 1.) It may well have served as a step, although a little high for such a purpose. This was one of two houses where such a slab was found in the antechamber. In many of the others there was a similar stone in front of the main doorway.

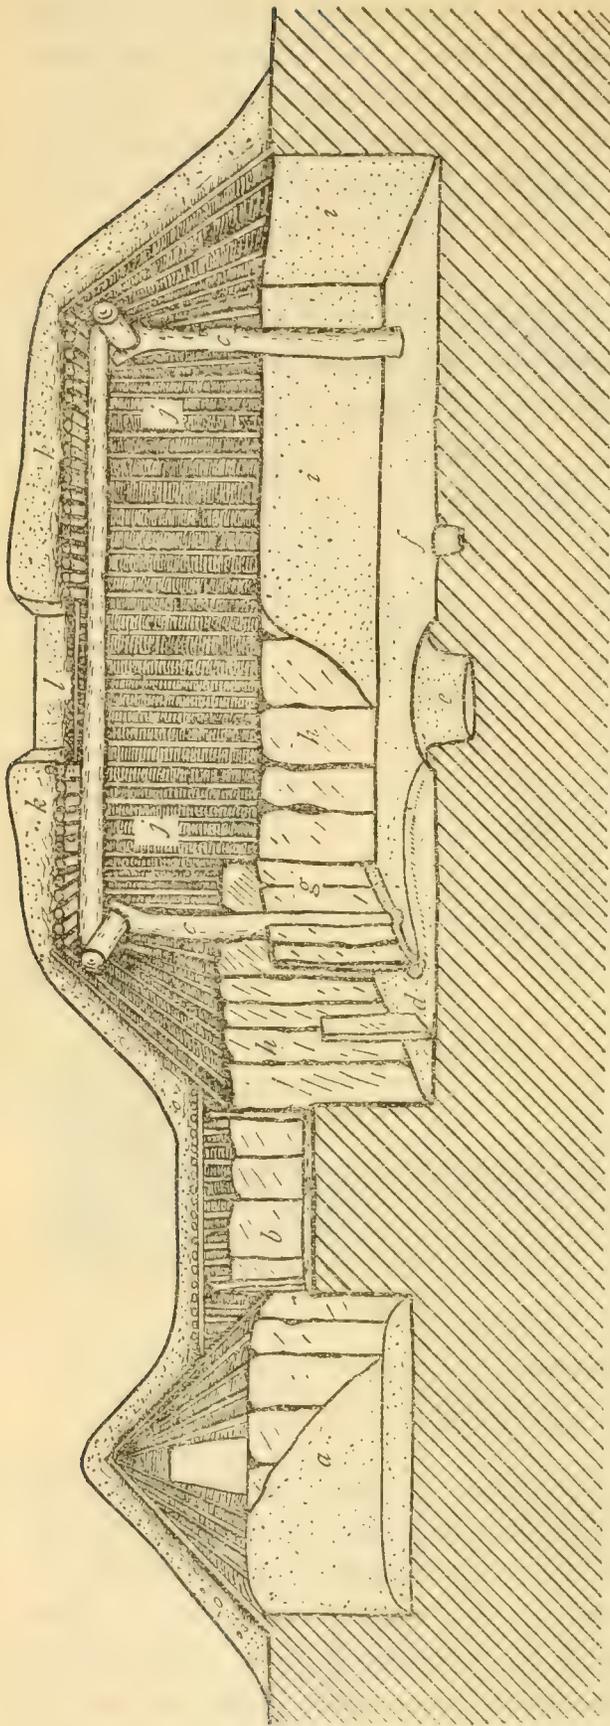
FIG. 2.—Postulated method of house construction. *a*, Antechamber. *b*, Passage. *c*, Support posts. *d*, Deflector. *e*, Fire pit. *f*, Sipapu. *g*, Compartment wall. *h*, Slabs lining periphery of pit. *i*, Plastered walls. *j*, Pole and brush framework. *k*, Earth and plaster covering on superstructure. *l*, Smoke hole

forked, a tree trunk with a suitable crotch having been used for the purpose, to hold crossbeams. The latter formed a rectangular framework against which were placed the upper ends of small poles, the lower ends of which were embedded in the earth around the periphery of the excavation. These formed the sloping upper walls of the house. There was plentiful evidence of these small poles not only in this ruin but in many of the others as well. The rectangular space at the top probably had a flat roof with an opening in the center to serve as a smoke hole, possibly on occasions as an entrance. The entire framework was then covered with twigs, bark, leaves, earth,

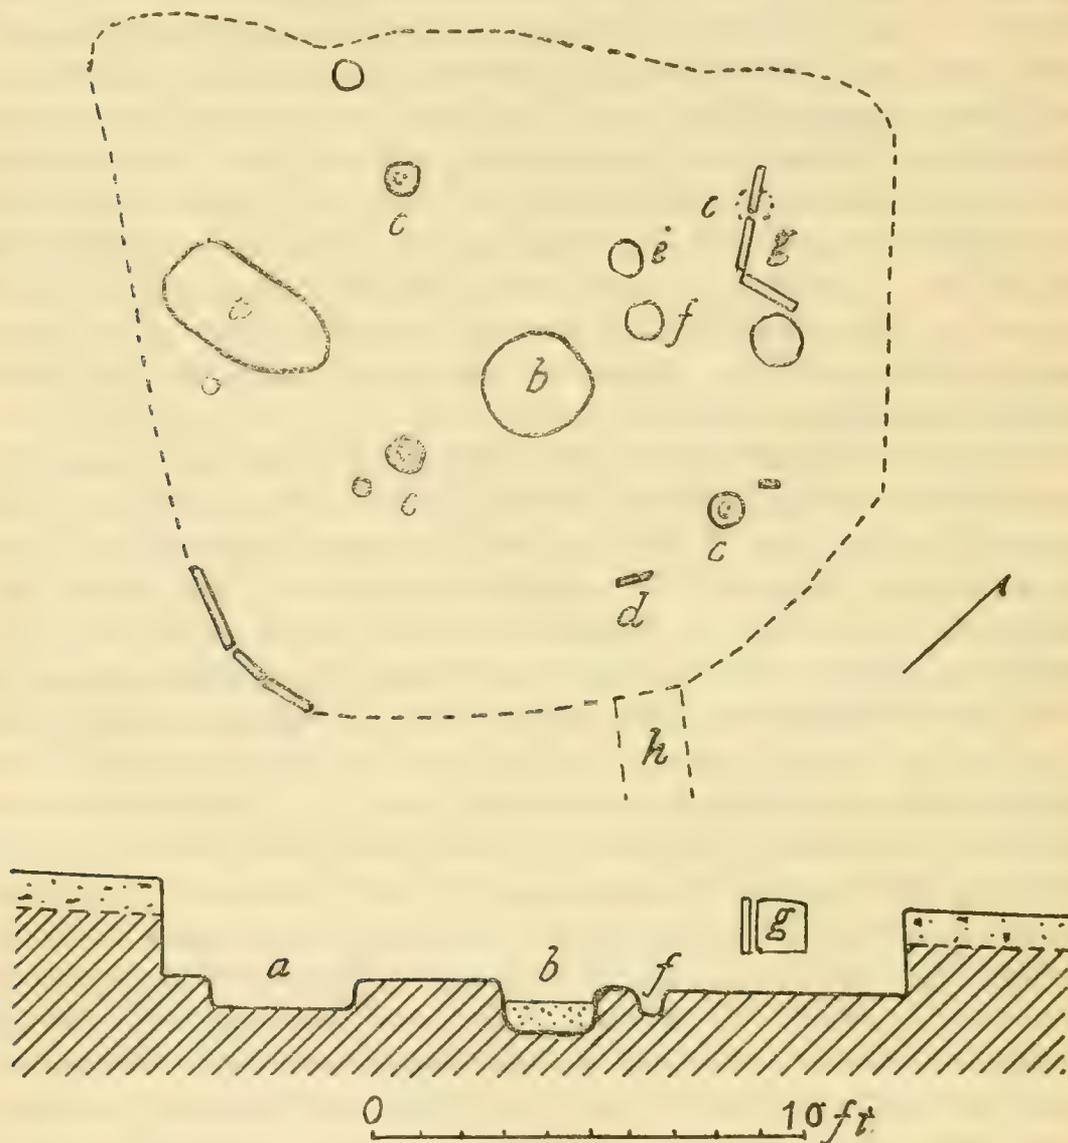
FIG. 3.—Plan of House B. *a*, Oval pit in floor. *b*, Fire pit. *c*, Support posts. *d*, Deflector. *e*, Storage hole in floor. *f*, Sipapu. *g*, Bin erected after abandonment of house. *h*, Remains of passage

been used to line the excavation had been removed, probably for use in other structures. Some of them possibly found their way into the walls of house A. From what remained of the dwelling, however, it was possible to determine that it had in a general way corresponded to the others. It had been irregular in shape (fig. 3), although it might be referred to as roughly rectangular.

During the excavation of the room it was found that the bin indicated by the slabs in the north corner (fig. 3) was of later date. The bottom of this small cist was 1 foot (30.48 cm.) above the floor of the dwelling. At some time after the house had been abandoned a storage cist had been built on the same site. This feature was apparent in several of the dwellings and indicates that all of them were not occupied contemporaneously.

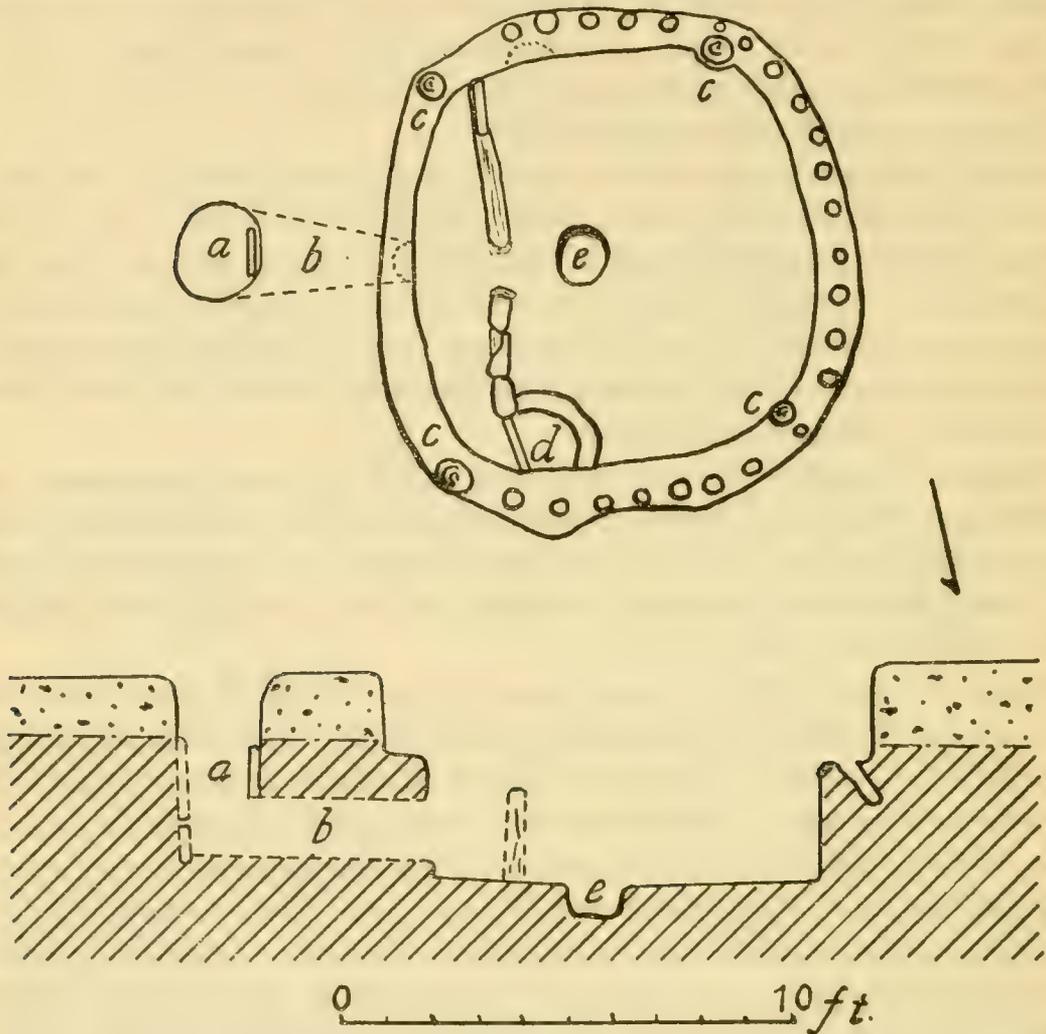
FIG. 4.—Plan of House C. *a*, Ventilator shaft. *b*, Ventilator passage. *c*, Support posts. *d*, Corner bin. *e*, Fire pit

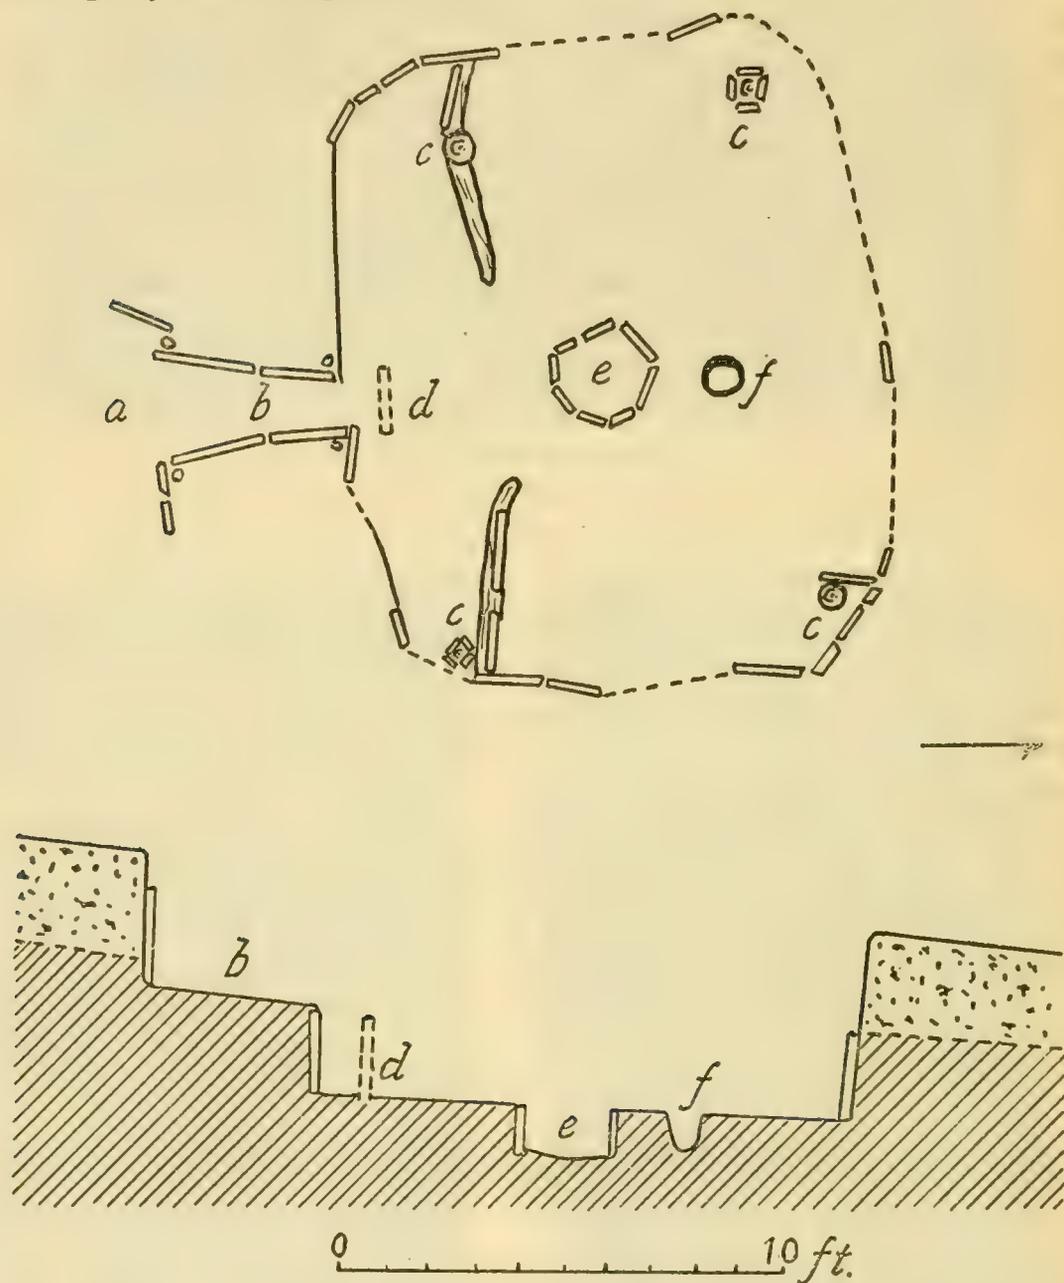
FIG. 5.—Plan of House D. *a*, Antechamber remains. *b*, Passage. *c*, Support posts. *d*, Deflector. *e*, Fire pit. *f*, Sipapu

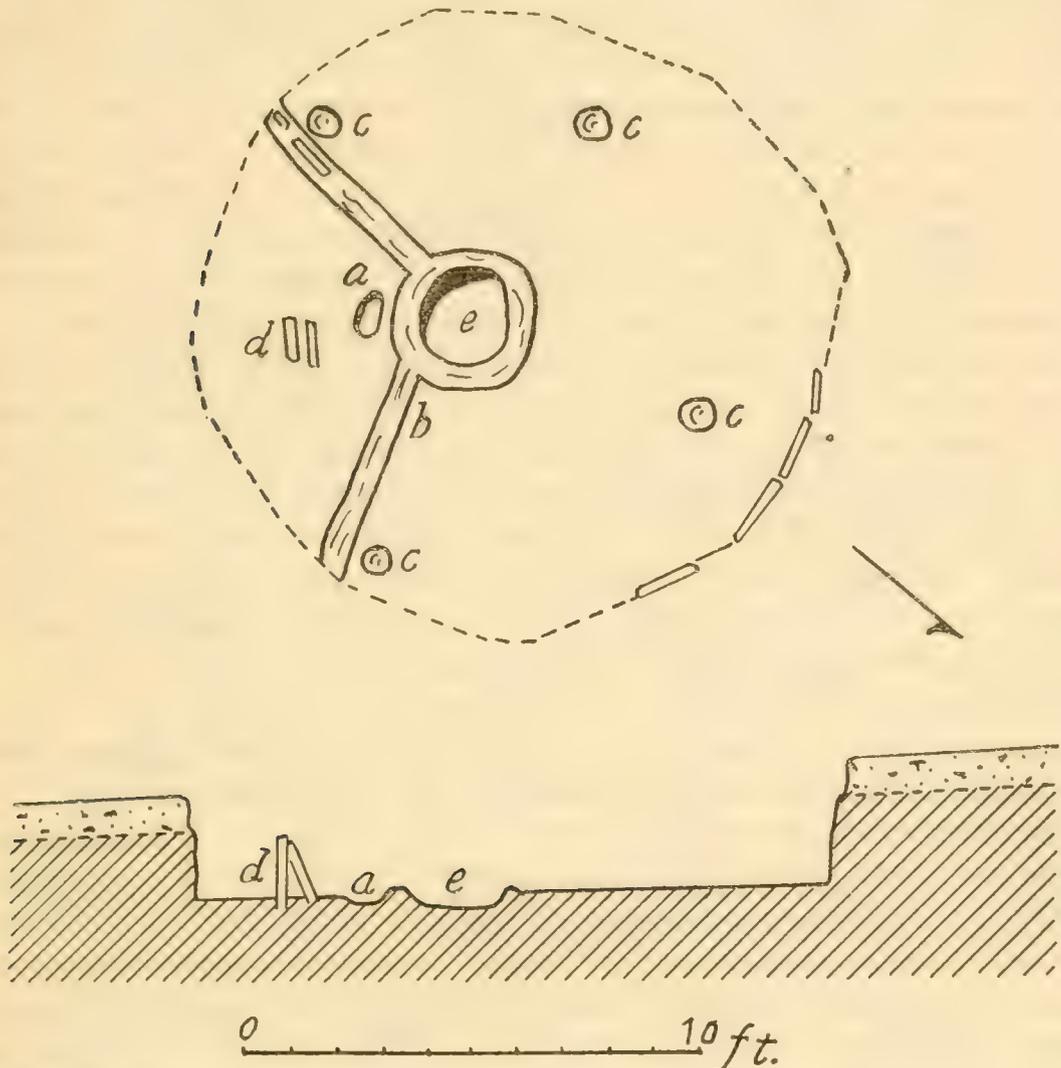
FIG. 6.—Plan of House E. *a*, Oval depression in floor. *b*, Adobe ridge. *c*, Holes for support posts. *d*, Deflector. *e*, Fire pit

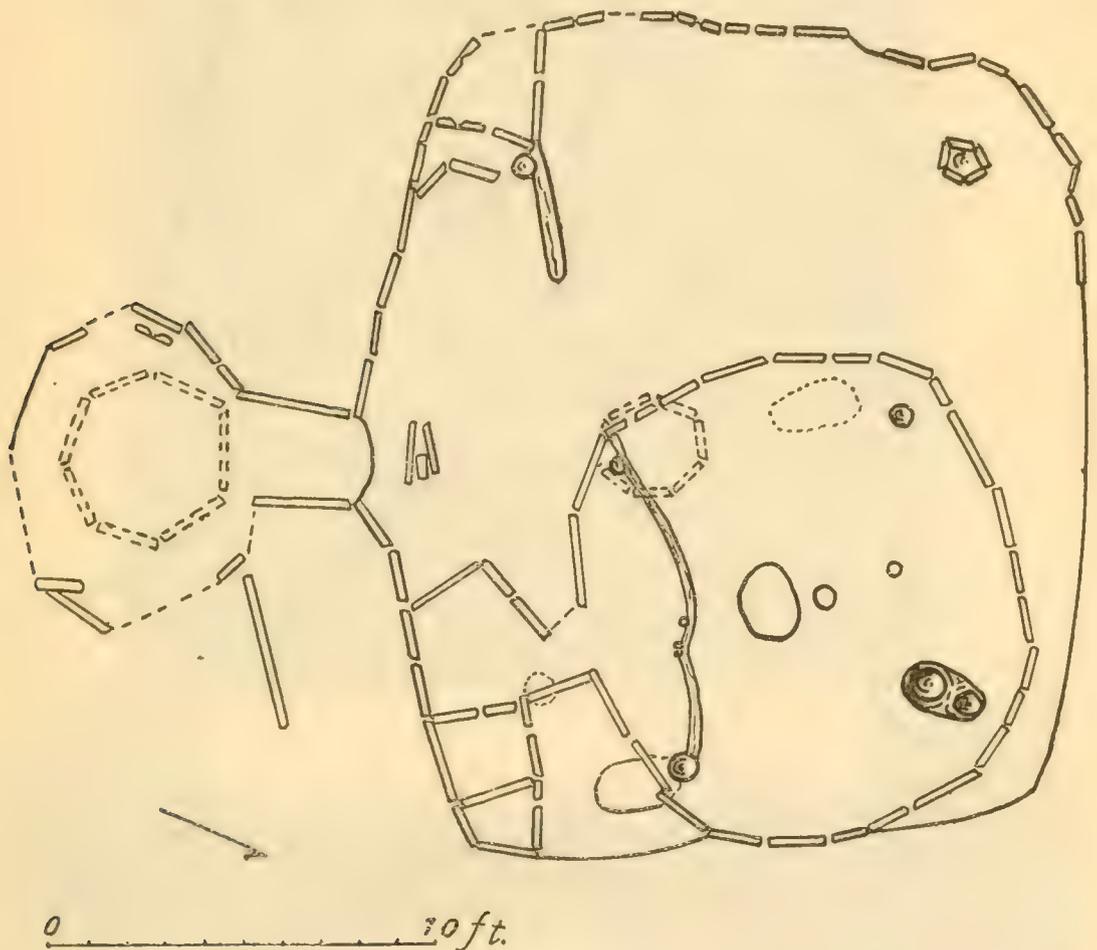
FIG. 7.—Plan of the F House group, showing both structures in complete relationship

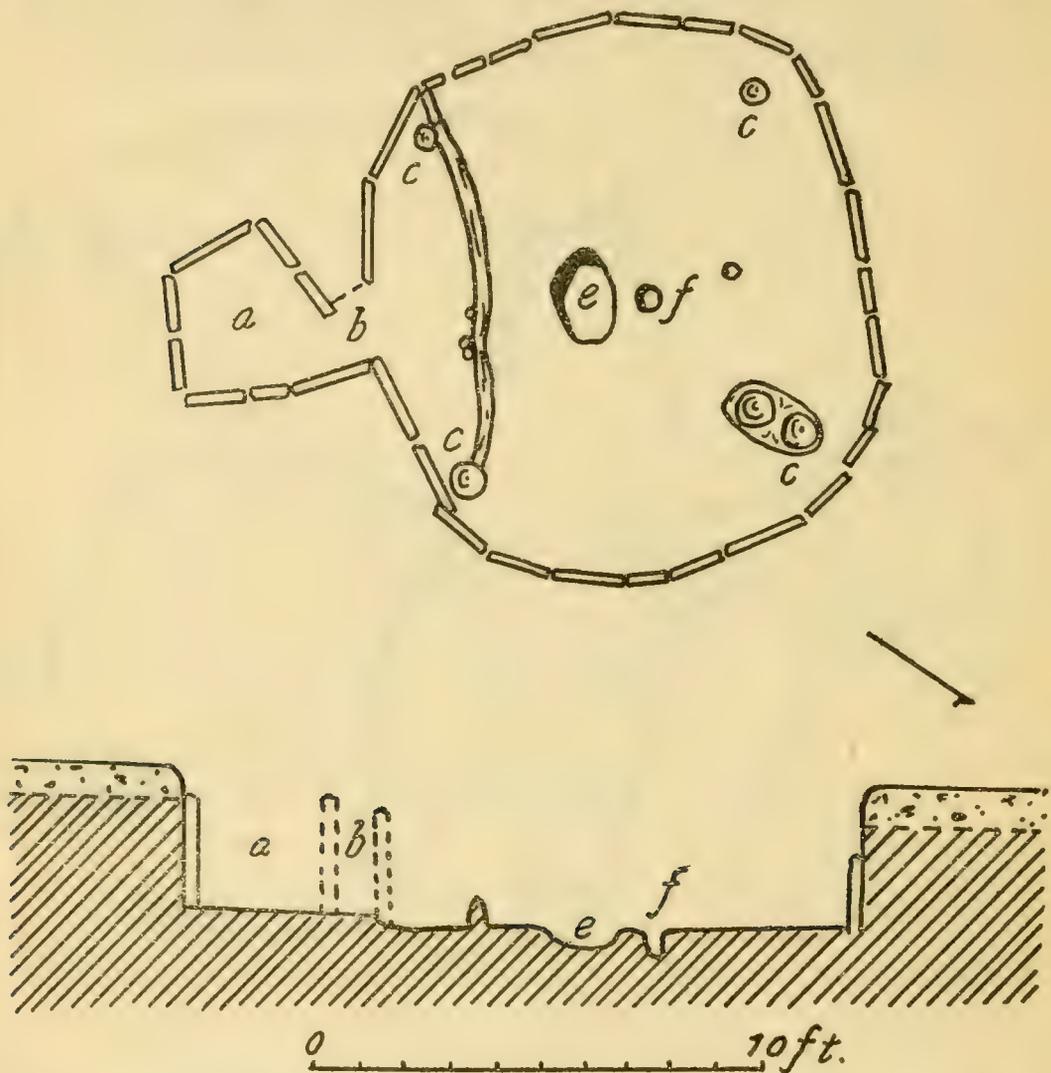
FIG. 8.—Plan of House F. *a*, Antechamber. *b*, Passage. *c*, Support-post holes. *e*, Fire pit. *f*, Sipapu

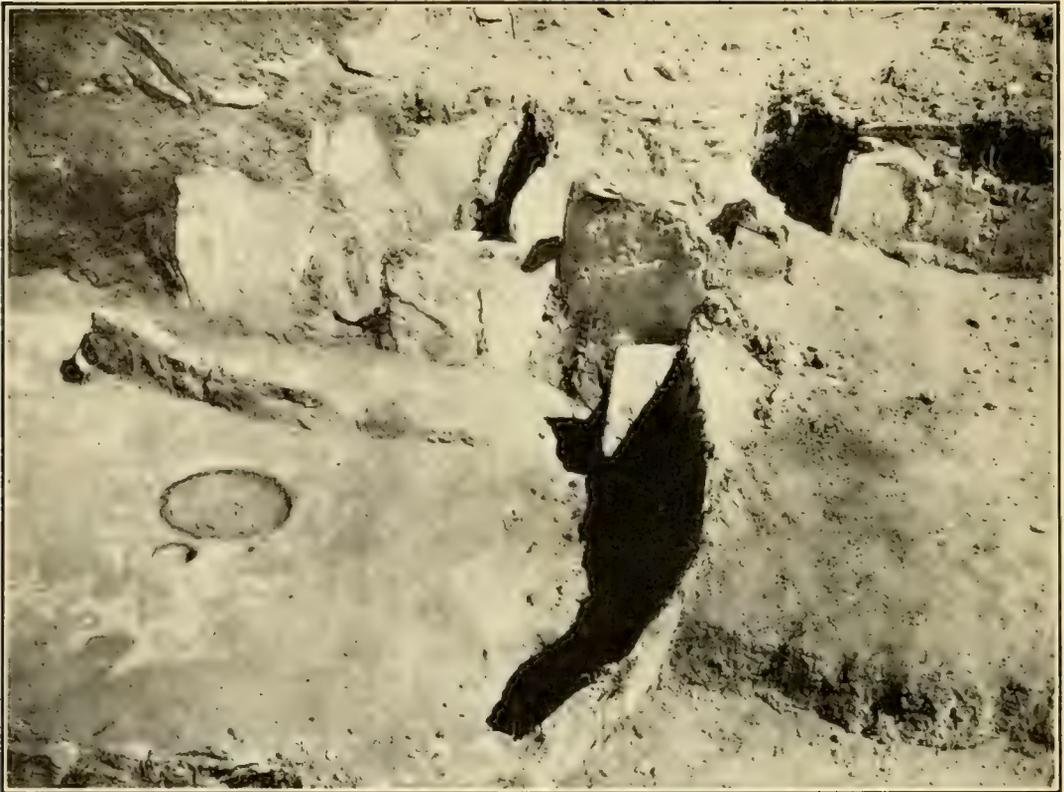
a, House F-1 during excavation. Rough masonry may be noted at sides of doorway. House F in left foreground

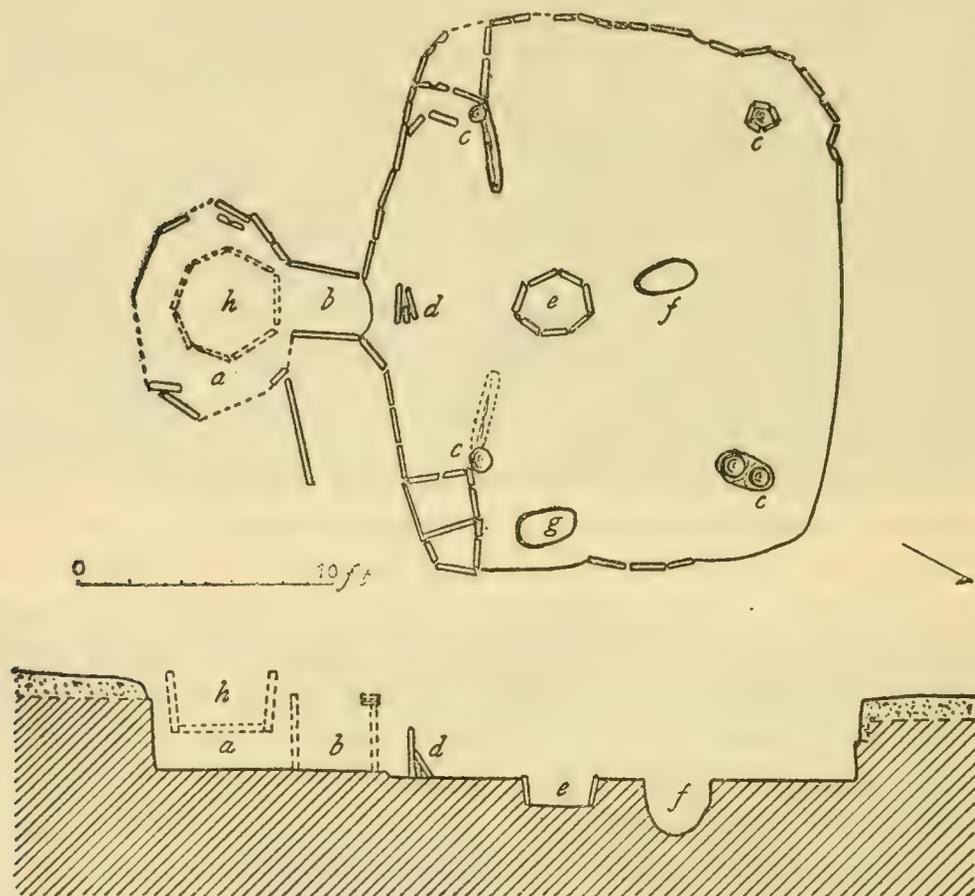
FIG. 9.—Plan of House F-1. *a*, Antechamber. *b*, Passage. *c*, Holes for support posts. *d*, Deflector. *e*, Fire pit. *f*, Oval hole in position normally occupied by sipapu. *g*, Second fire pit. *h*, Fire pit placed in antechamber at date subsequent to abandonment of house

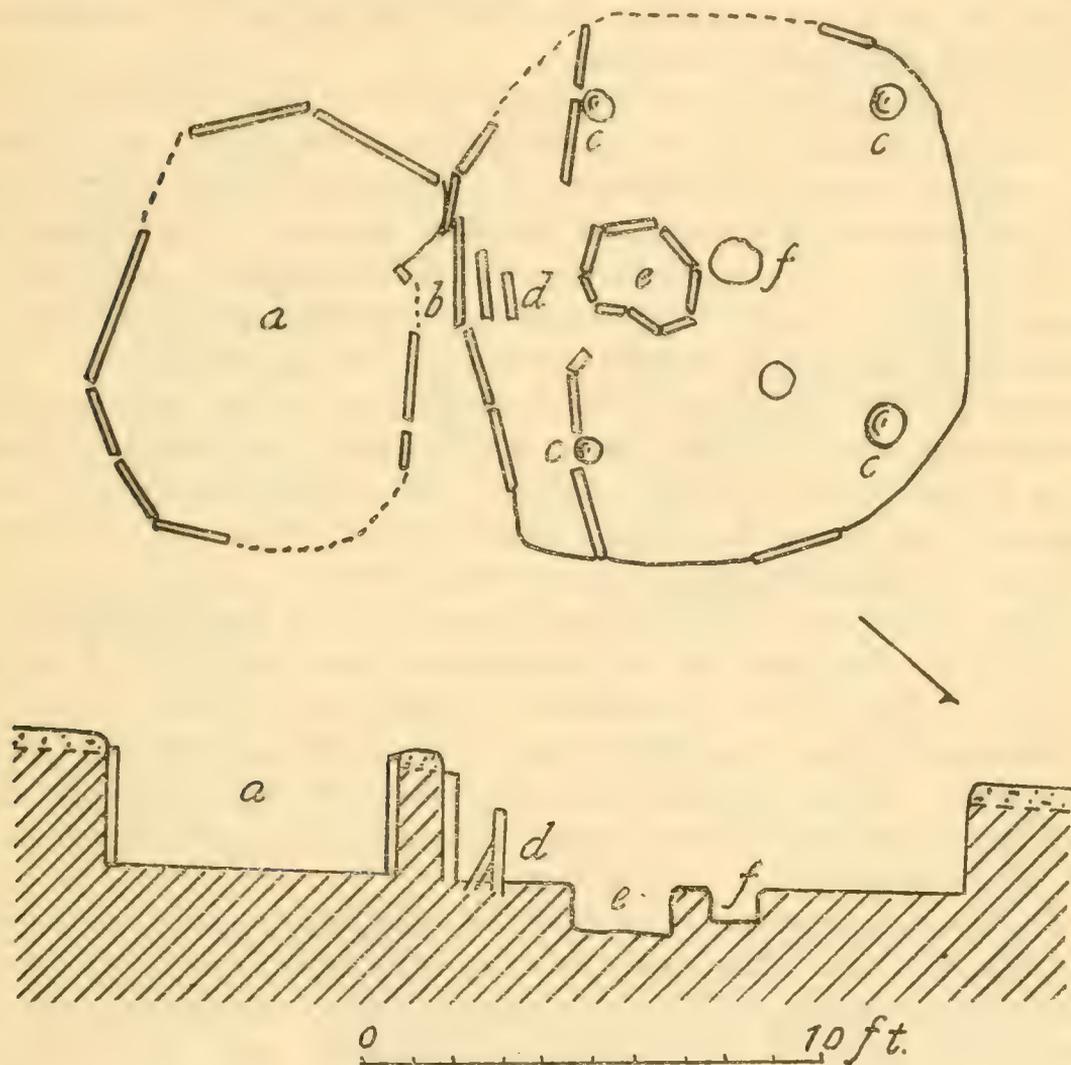
FIG. 10.—Plan of House G. *a*, Antechamber. *b*, Possible short passage. *c*, Holes for support posts. *d*, Deflector. *e*, Fire pit. *f*, Sipapu

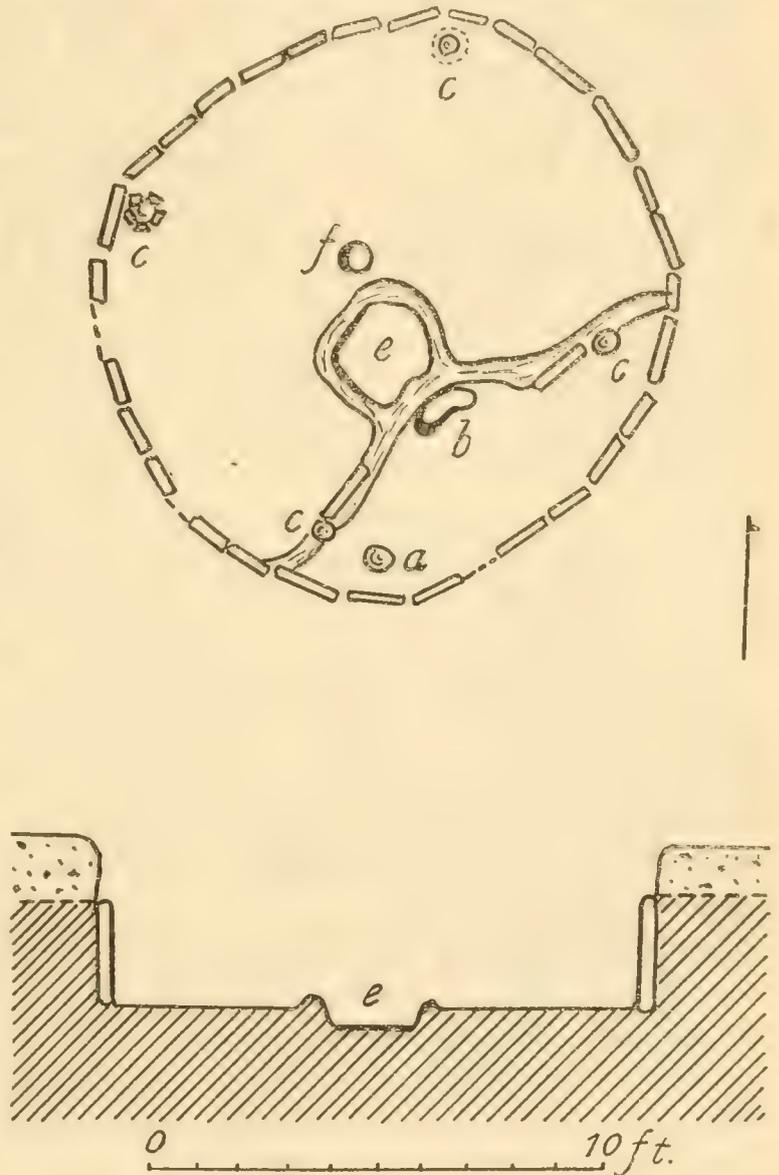
FIG. 11.—Plan of House H. *a*, Storage hole in floor. *b*, Oval depression in floor for end of ladder. *c*, Holes for support posts. *e*, Fire pit. *f*, Sipapu

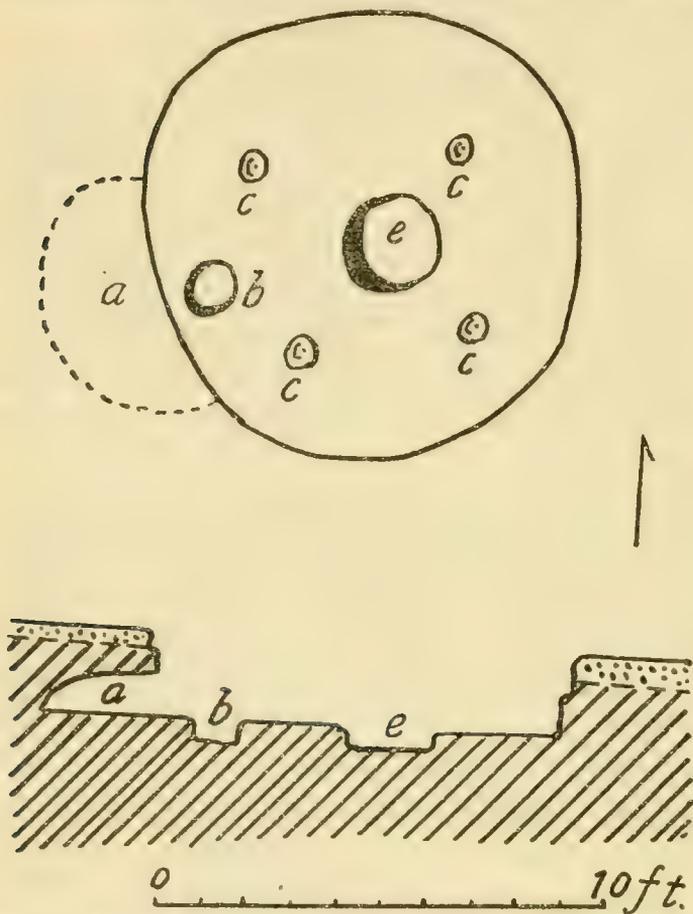
FIG. 12.—Plan of House I. *a*, Wall recess. *b*, Storage pit in floor. *c*, Support-post holes. *e*, Fire pit

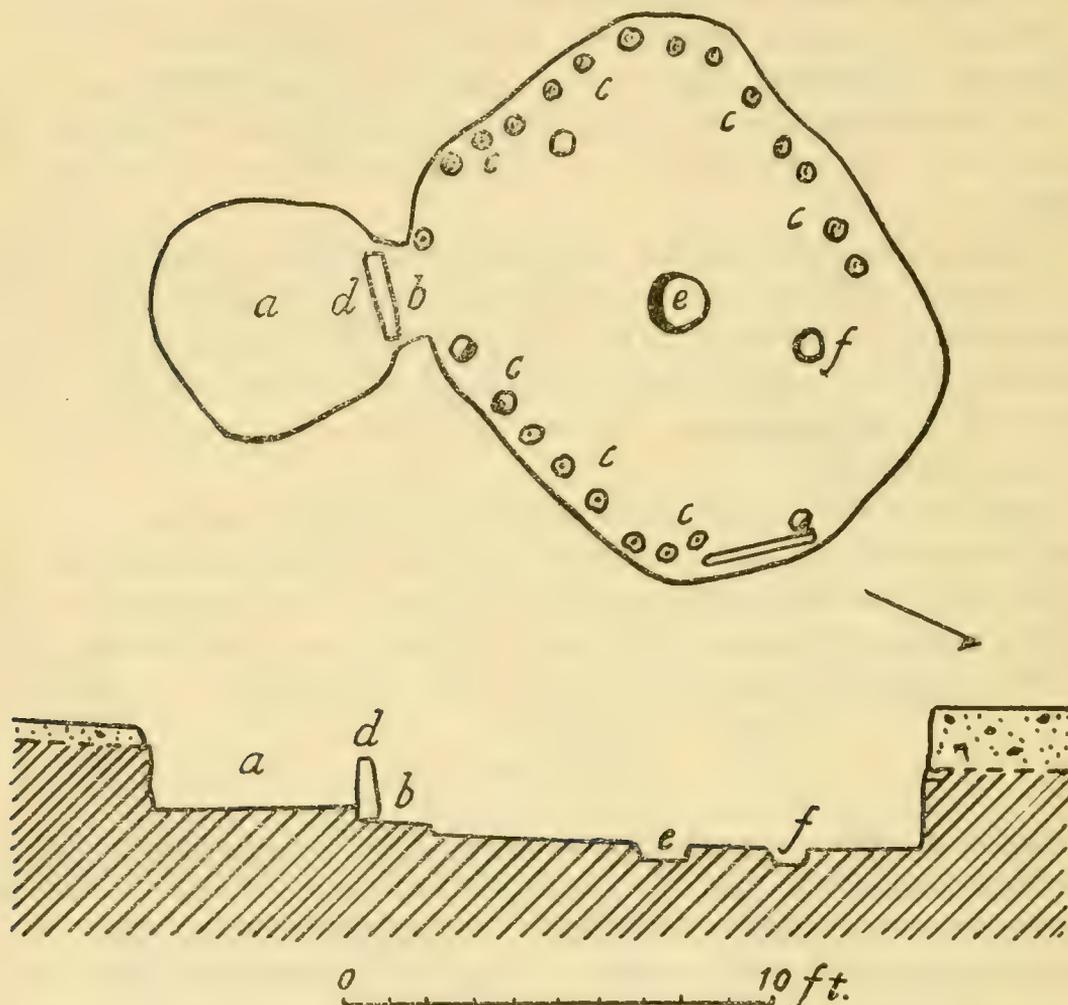
FIG. 13.—Plan of House J. *a*, Antechamber. *b*, Doorway to room. *c*, Holes for posts used in wall construction. *d*, Possible deflector. *e*, Fire pit. *f*, Sipapu

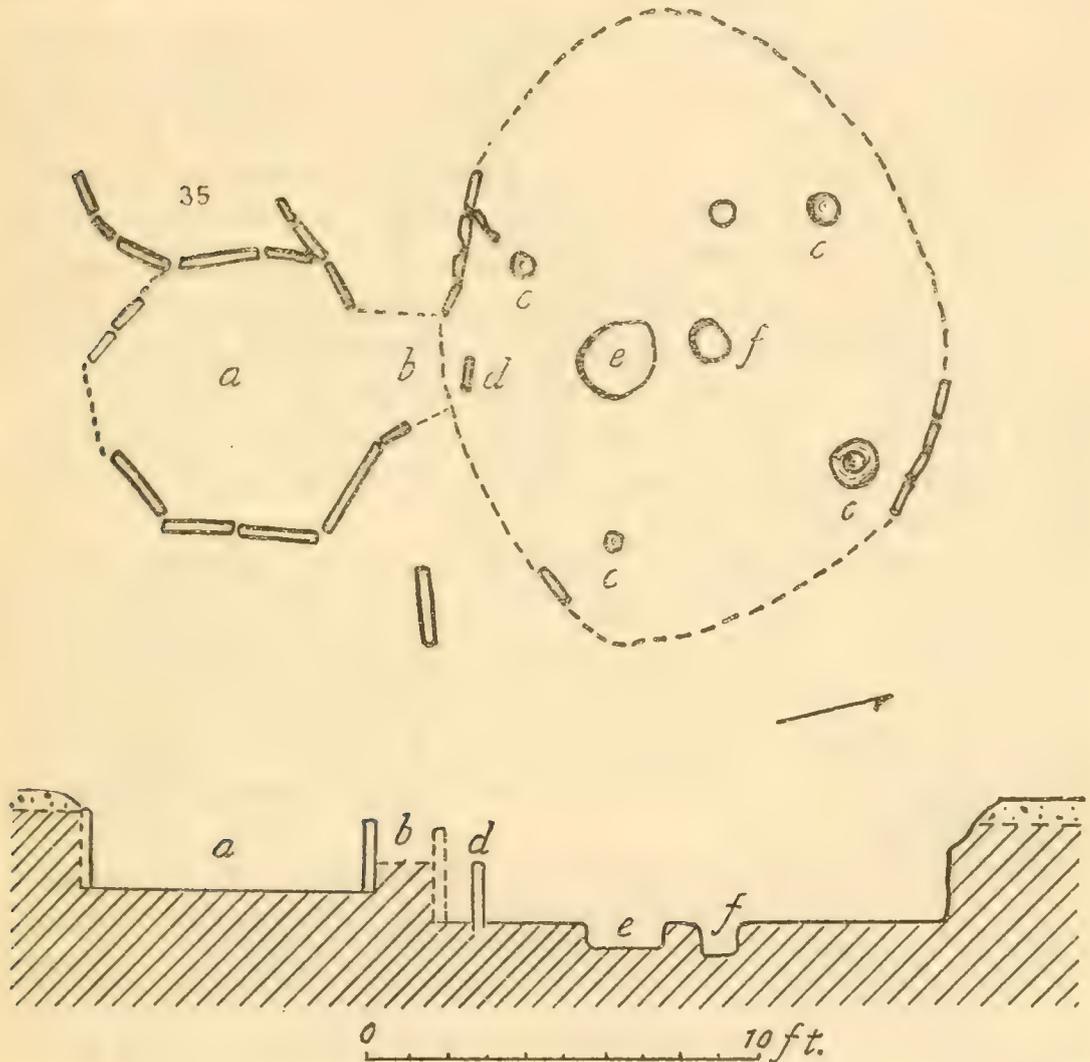
FIG. 14.—Plan of House K. *a*, Antechamber. *b*, Passage. *c*, Holes for support posts. *d*, Deflector. *e*, Fire pit. *f*, Sipapu

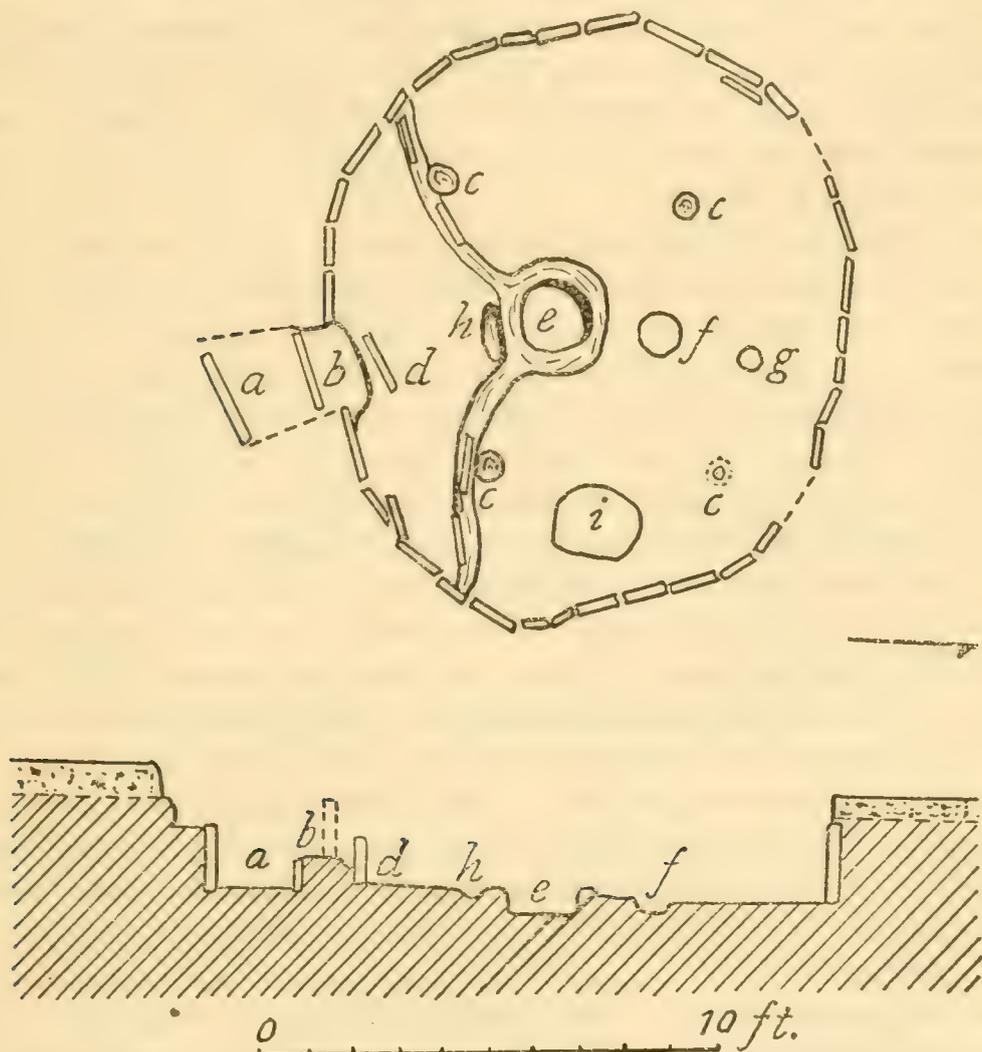
FIG. 15.—Plan of House L. *a*, Short passage. *b*, Step between passage and room. *c*, Holes for support posts. *d*, Deflector. *e*, Fire pit. *f*, Sipapu. *g*, Storage hole in floor. *h*, Oval depression, possibly for ladder end. *i*, Second fire pit

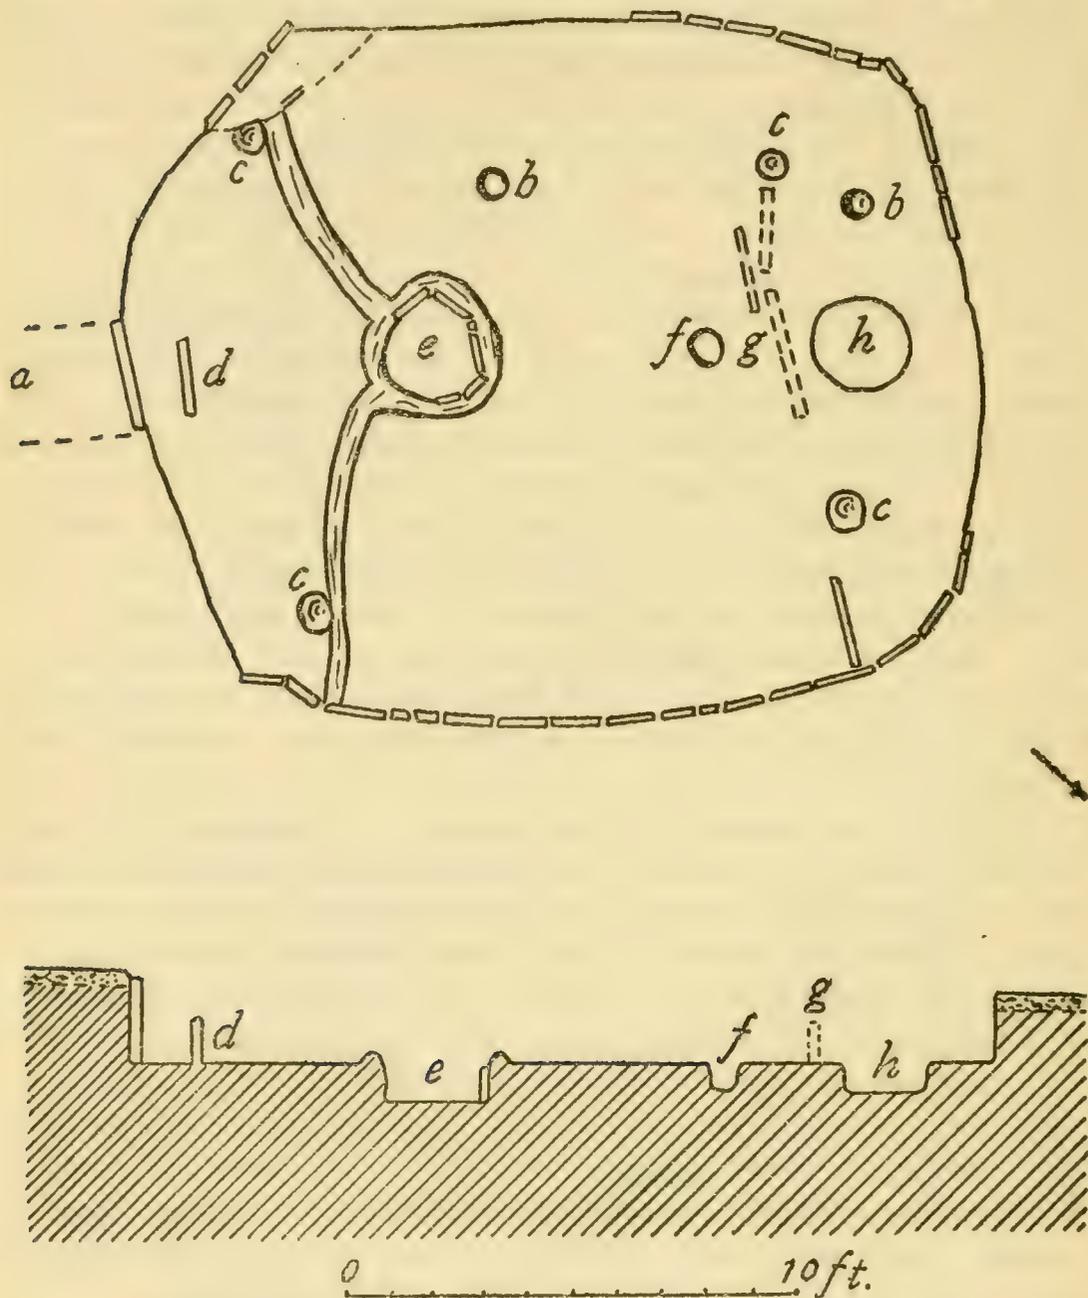
FIG. 16.—Plan of House M. *a*, Passage. *b*, Storage pits in floor. *c*, Holes for support posts. *d*, Deflector. *e*, Fire pit. *f*, Sipapu. *g*, Wall for second compartment. *h*, Fire pit

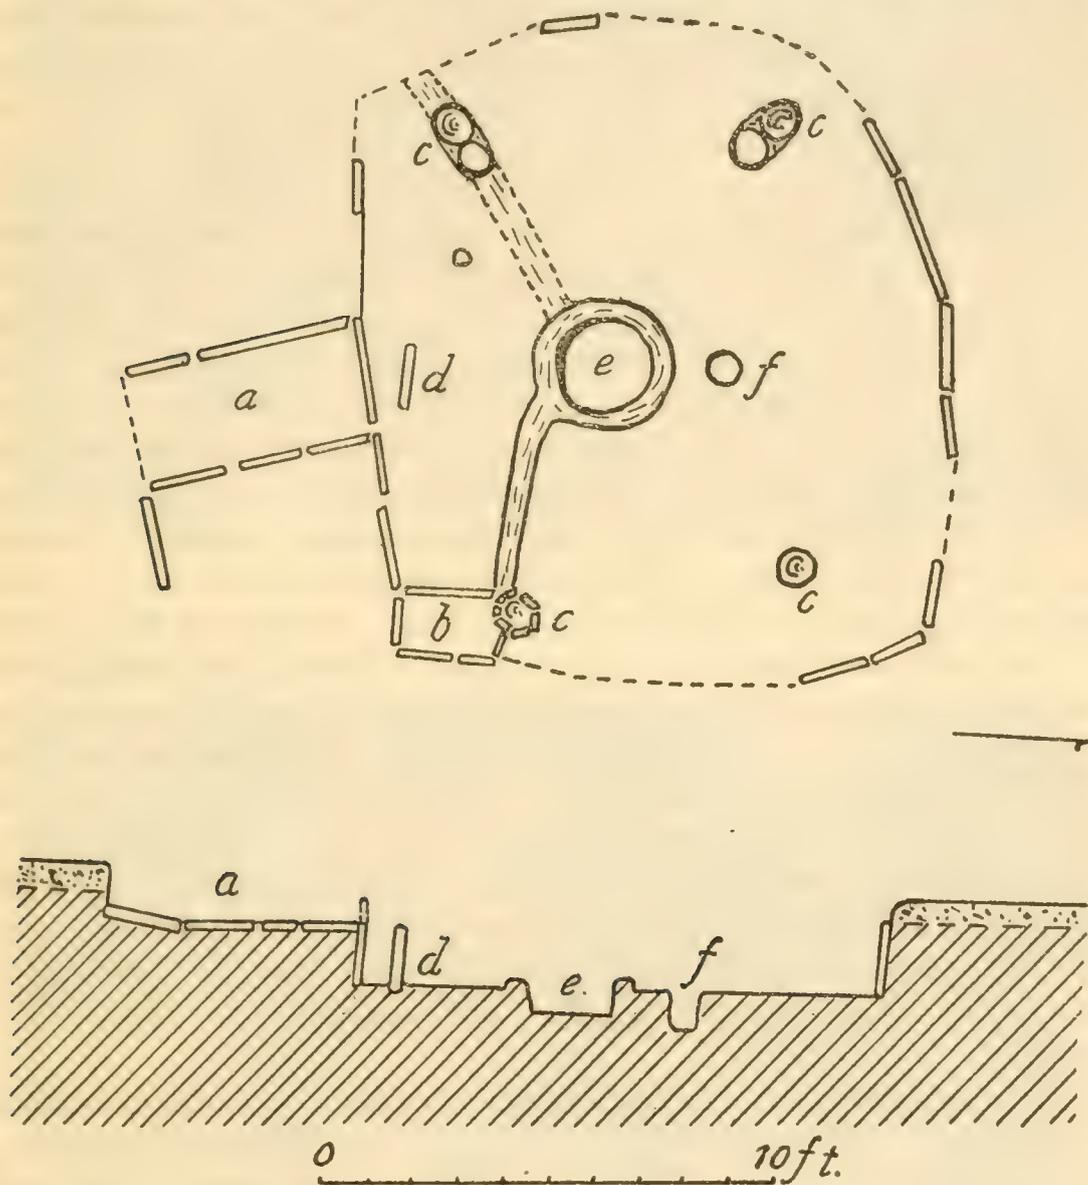
FIG. 17.—Plan of House N. *a*, Passage. *b*, Corner storage bin. *c*, Holes for support posts. *d*, Deflector. *e*, Fire pit. *f*, Sipapu

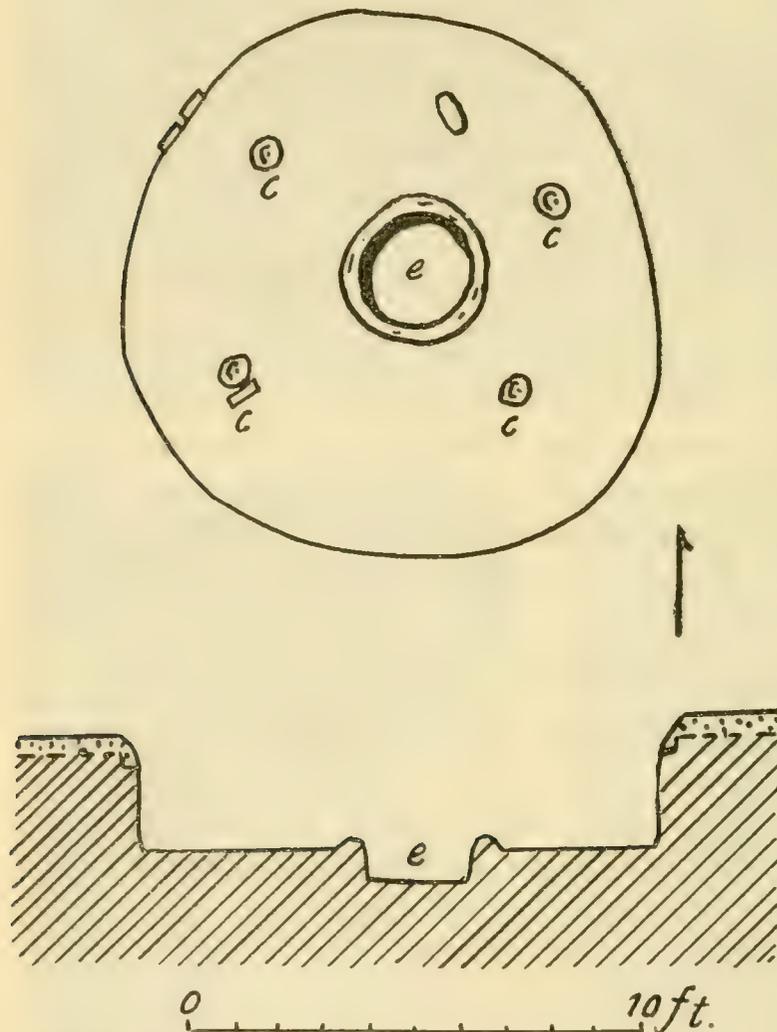
FIG. 18.—Plan of House O. *c*, Holes for support posts. *e*, Fire pit

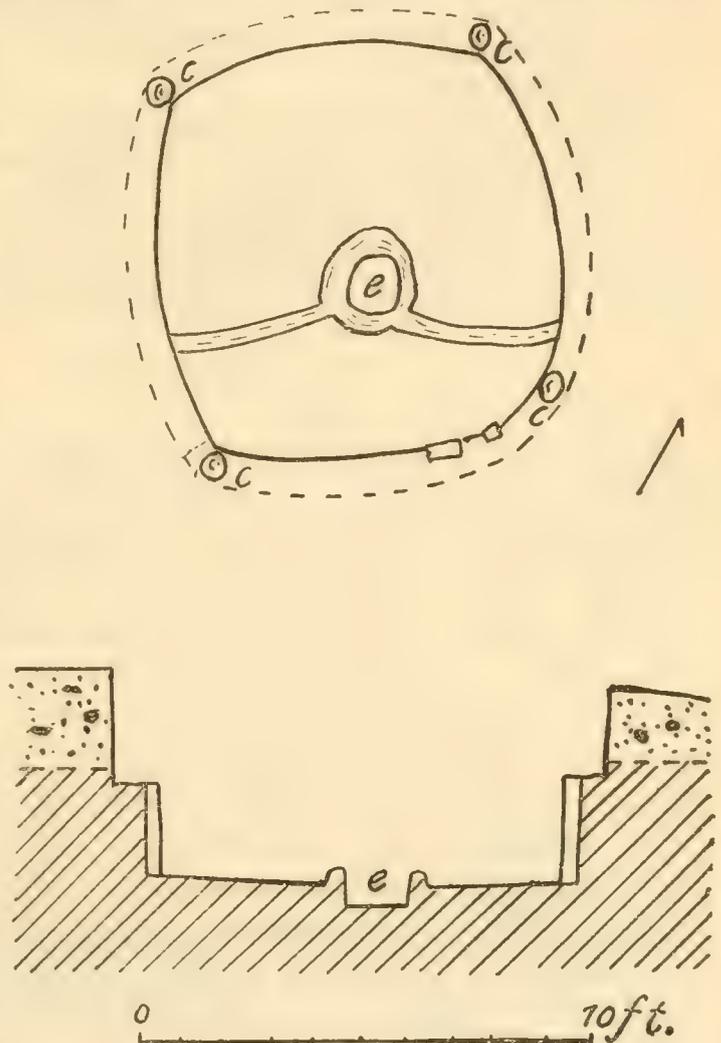
FIG. 19.—Plan of House P. *c*, Holes for support posts.
e, Fire pit
